'From the Bilge' by Tech commodore Bob Banzett

## MAST STEP REPAIR

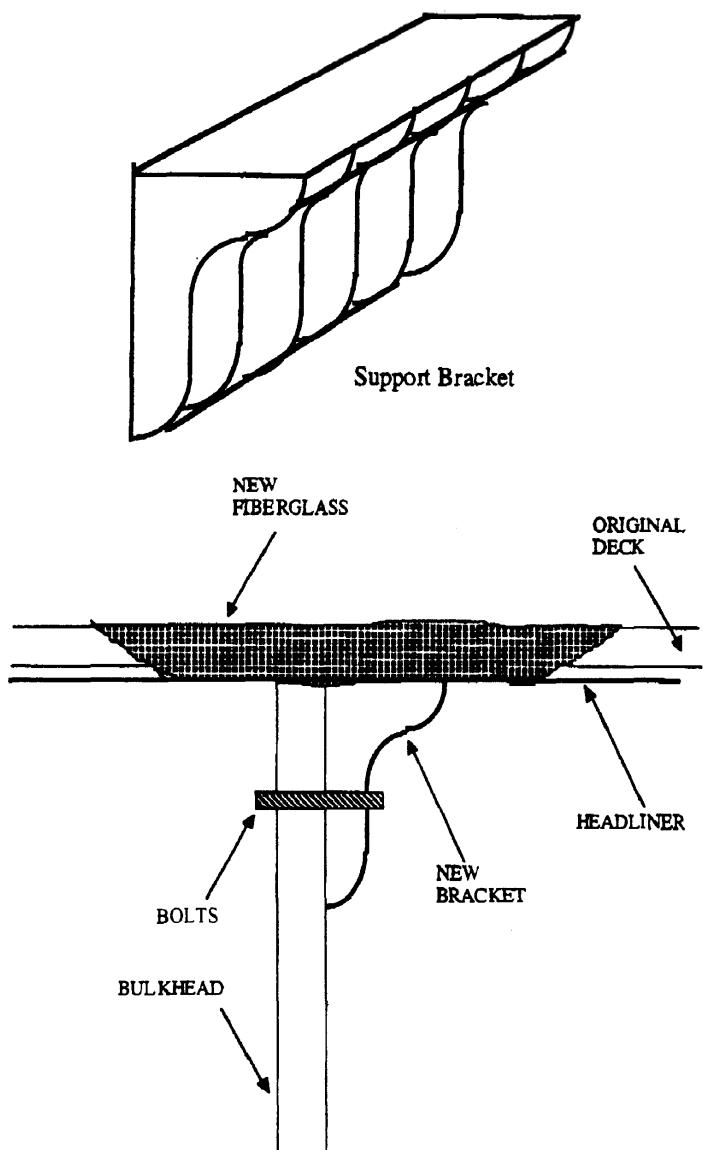
I was surprised to find that under the step the deck was cored with balsa! No wonder it compressed under the load. The balsa was not wet or delaminated -- it just isn't strong enough to bear the compression load after all these years. I'm a bit surprised it didn't fail sooner. The forward third of the deck under the step was cored with plywood -- I suspect the plywood was placed in the wrong spot on my boat during deck layup. This could be a widespread problem, invisible once the deck is laid up.

Using the upper surface of the cabin headliner as a base I laid fiberglass mat, roving, and cloth in layers with West epoxy until I filled the hole *to the* level of the deck (fairing the last bit with high strength filler). Very solid. I built a laminated wooden bracket about 6" long which extends 3" from the starboard face of the bulkhead, and supports the cabin headliner. (*Cut. the* shape indicated from 3/4" marine plywood, then epoxy together and sand it even.) It is bedded with epoxy putty, and bolted to the 2" thick bulkhead with three SS bolts (3/8"); one of the bolts runs through the angle iron inside the corner of the bulkhead. At this point I could have re-installed the wooden step block (or a new one) and had a solid repair -- much stronger than the original. I chose to fabricate an aluminum base and tabernacle, which I will report on in another installment if it works out well.
