Skip-Jack was produced in 1968 By Allied Boat Company. We have been restoring her for the past 10 years and this year is the year of the Fixed Port Replacement. The ports were not original and have been replaced by the previous owner and unknown time in the past.

We took it upon ourselves to design and have fabricated a set of replacement ports, an ambitious project which has been ongoing over the last year.

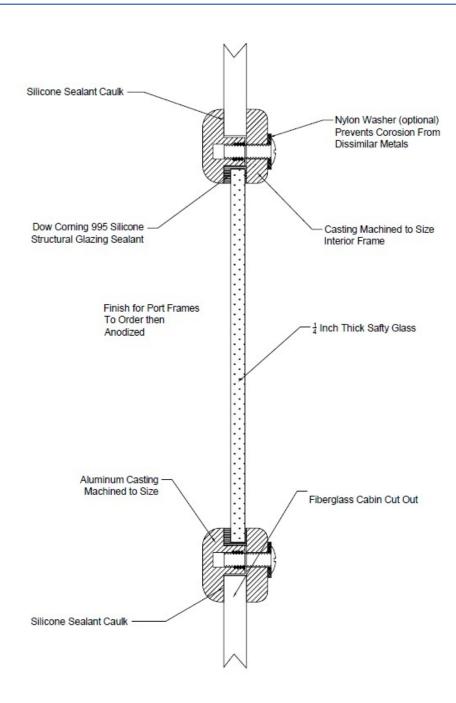
Frames with Glass pane

First, we made a pair of molds from which aluminum castings, one for the interior frame and the other for the exterior frame. We chose safety glass this time because we thought the Lexan didn't have the life expectancy we were looking for, which is installed in the Exterior Frame.

Then the castings were machined on a CNC mill to my specifications, bead blasted then Anodized.

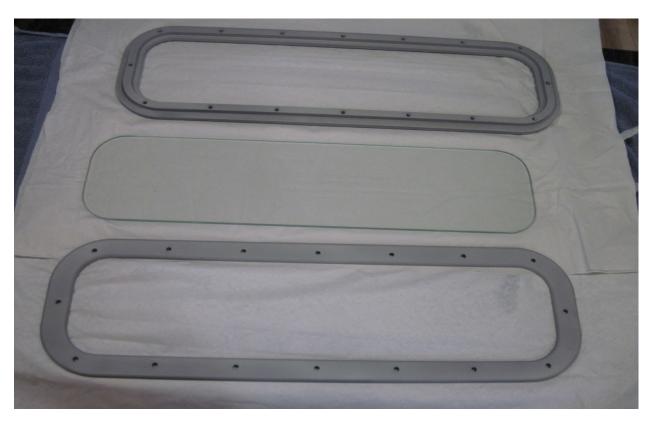
Helicoill Inserts

The blind holes were drilled in the exterior frame and tapped for ¼ -20 Stainless Helicoids to help prevent electrolysis between the dissimilar metals (Stainless Crews and aluminum frames)

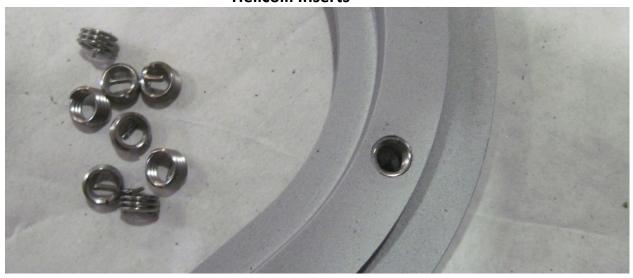
The glass was set in using a butyl rubber strip between the outside frame and the glass. There will be an interior gasket between the interior frame and the glass which will compress securing and sealing the unit to be water tight.

Previously we used a silicon gasket to seal the exterior frame to the cabin. Some may choose to use Silicon or some other caulk, but I had good luck with the gasket.

We designed the exterior frame to be also sealed from the inside, as a double barrier against water intrusion. It protrudes into the cabin, so that water should have a more difficult time finding its way through. The previous ports had corrosion on the inside and some screws were beginning to freeze in place. We have found that using Never Seize on all fasteners greatly helped years later when they needed to be removed for service.

These ports were made slightly big, so I had to trim the cutout slightly to fit them in. This was Intentional in order to secure the tightest fit possible.

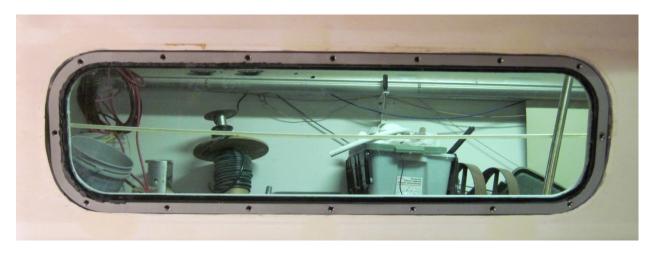
Interior View, without frame attached.

We were not especially pleased with the finish. They were Bead Blasted then Anodized. We are looking into the other available finishes among which are polished finish, Brushed Aluminum finish and anodized with a color. The Final ports were finished with a brushed aluminum finish then anodized. They have been in service for one season now and there are no leaks and the look like the original ports.

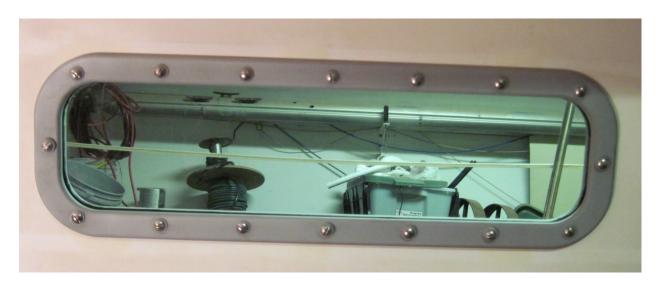
Interior View
