Head Refit for Skip-Jack

In 2009, Skip-Jack was refitted with a new Raritan Marine Elegance electric head. We were interested in making a simple clean look with a minimum of head odors and the capacity to go a week or more while living aboard without being forced to go offshore to pump-out or having to stop in at a pump-out station. In our home port there is a pump-out boat which is free, but we are hoping to make some voyages to the Chesapeake and south where these services are not readily available. The old 6 gallon tank did not allow enough time between pump- outs.

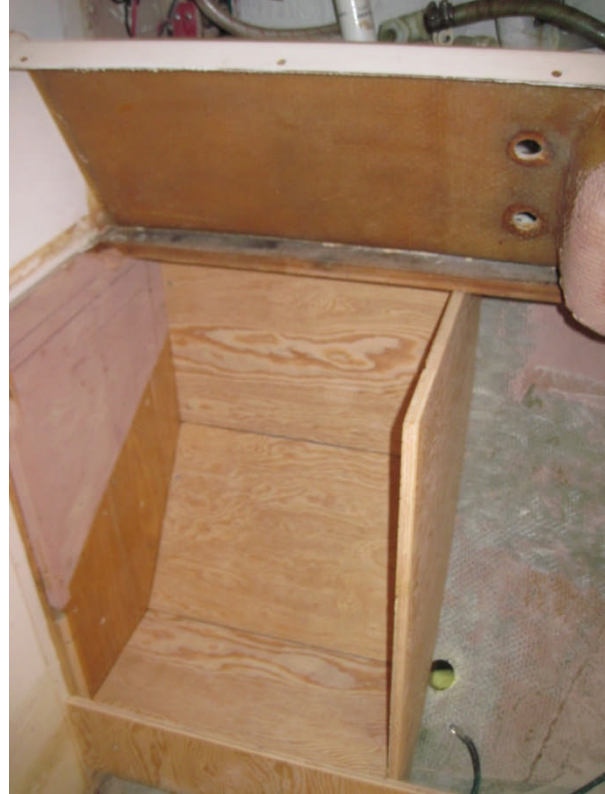
Next, we fabricated a fiberglass panel with gel coat on one surface. This was accomplished by using a piece of glass (an old sliding door) as a mold. It was placed on a pair of saw horses making sure it was perfectly flat in all directions, then cleaned and coated with 4 layers of mold release wax. We then rolled on 2 layers of white gel coat. Once the gel coat was set up enough, a layer of fiberglass mat was laid down over the gel coat and soaked with polyester resin. A second layer of mat was applied then rolled with a fiberglass roller to remove the bubbles and consolidate the mat. The precut plywood panel was coated with resin while the gel coat was setting up. It was then coated again just before laying it down on top of the wet mat and pressed in carefully to mate the two. Weights were added to the top of the plywood and then left overnight to fully cure.

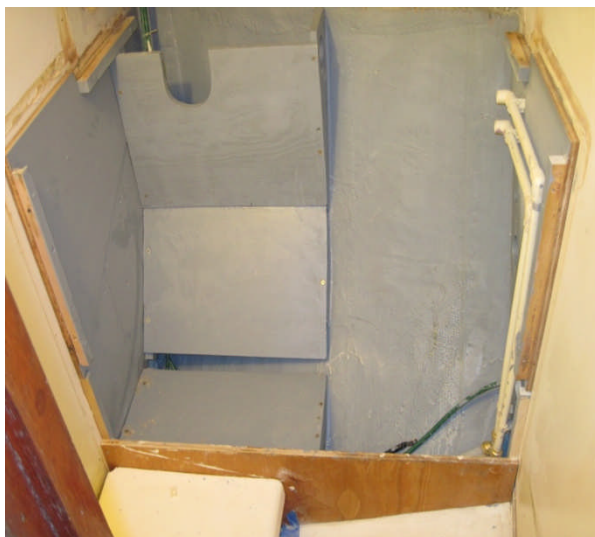
The panel was removed from the glass the next day. Then, with an angle grinder fitted with a cutting wheel, the fiberglass panel was cut leaving a ¼" or so extra over the edge of the plywood panel. Using a router with a following bit, the panel was trimmed to its exact size to match the pan. The drops from the rest of gel coat panel were saved for the fabrication of a new door and the panel applied to the bottom section of the sink bulkhead.

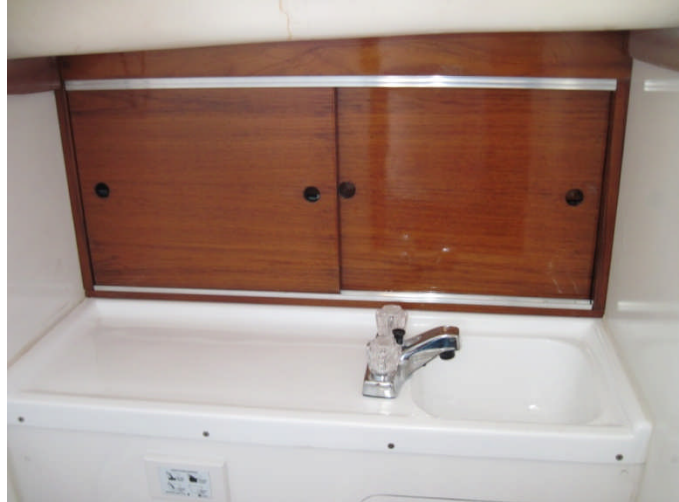
The remaining woodwork was sanded, fixed as needed and refinished before installation. The tracks for the sliding doors were destroyed while disassembling the cabinetry, but the hardware store had the exact same aluminum extrusions. The screw holes were bunged, sanded and then the last coat of finish was applied in place.

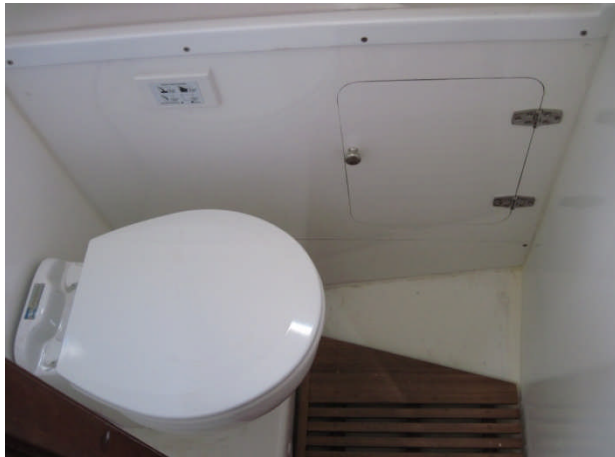
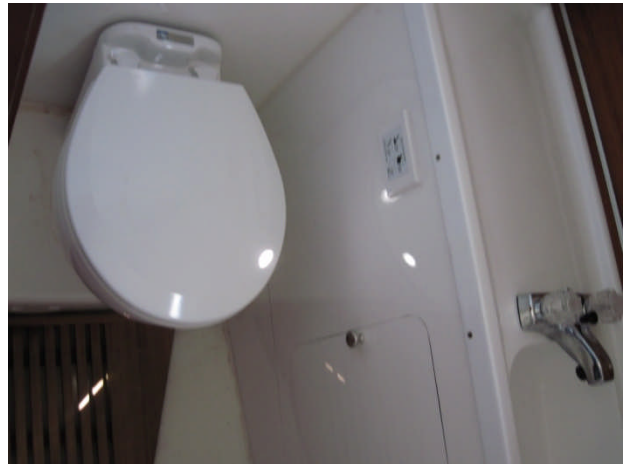
The Raritan Marine Elegance is one of a new breed of toilets available now. It uses about a cup of water on a normal flush. There are also controls which allow you to flush with more water, no water, or only add water without flushing.
